April 10, 2023

Project No.: 20234746.001A

Subject: Marsh Aviary Boardwalk – Structural Condition Assessment

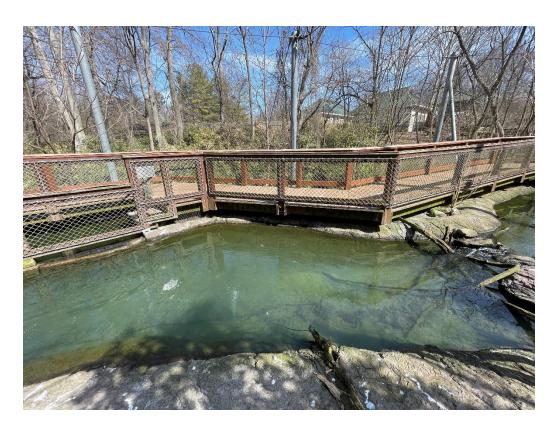
Photo 1 – Exhibit photo

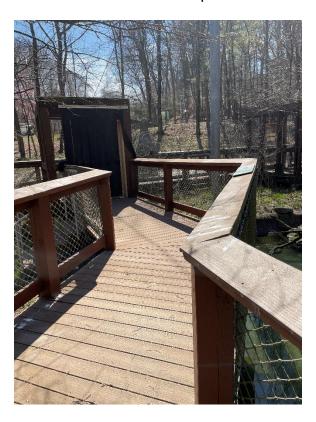
- 1. 2x composite decking appears to be in good condition (Photo 2).
- Overall handrail is weathered, but solid. The top rail is covered with a continuous piece of composite material that is buckling in several locations (Photo 3).
- 3. There are several handrail posts that are deteriorated, with up to 100% section loss (Photo 4). These locations are noted on the attached plans.
- 4. There are several areas with deteriorated joists. White fungus was observed on the sides of several joists. These locations are noted on the attached plans (Photo 5).

Photo 2 – Composite decking

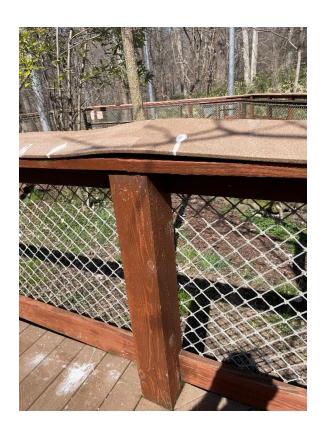
Photo 3 – Buckled composite railing topping material

- 1. Replace buckled composite handrail topping. Consider leaving gaps for expansion per manufacturer's recommendations.
- 2. Handrail posts with section loss shall be removed and replaced with 6x6 PT posts, reattach handrail.
- 3. Deteriorated joists shall be removed and replaced with 2x10 PT joists.
- 4. 2x10 girder side members that are deteriorated shall be removed and replaced with new 2x10 members. Joist and handrail post connections will need to be reinstalled. Joist connecters will likely need to be replaced.
- 5. Heavy steel connections will have to be reconnected where side members of girders are to be replaced. Interior 3x10 members will need to be observed once exterior, deteriorated 2x10 members are removed.

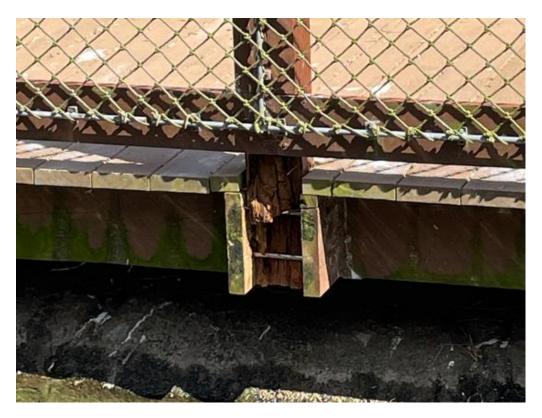
Photo 4 – Deterioration of 6x6 PT handrail post at base connection

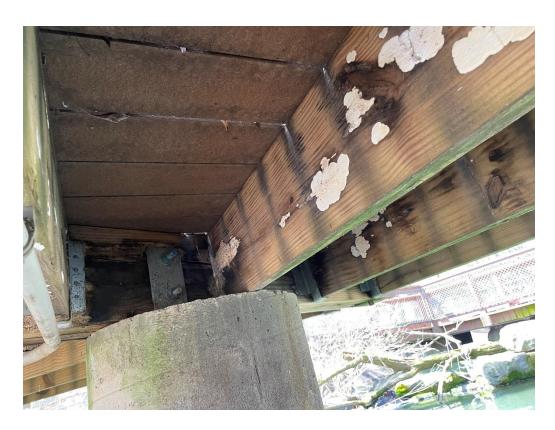
Photo 5 – Mold observed on the sides of rotted 2x10 joists

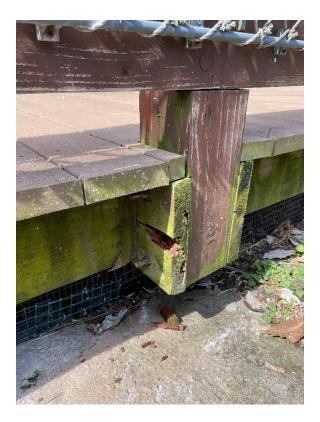
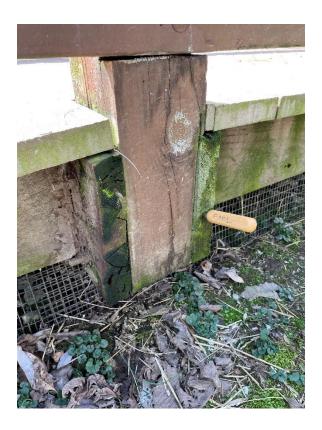
- 5. There are several locations where the outer, side 2x10 members of the built-up wood girders are rotted with up to 100% section loss (Photo 6-7). These locations are noted on the attached plans. Typically the interior (2)3x10 members appear to be in good condition.
- 6. Jambs that support hinges for steel framed gates exhibit damage and, per staff's accounts, have to continually be adjusted. Due to excessive weight of the gates, the attachment points of the hinges are damaged, causing the gates to sag and become out of plumb (Photo 8).
- 7. Joist hangers appear to be in good condition overall.
- 8. Heavy steel connections appear to be in good condition.
- 9. Concrete piers appear to be in good condition.

Photo 6 – Rotted 2x10 side members of built-up wood girder

Photo 7 – Rotted 2x10 side members of built-up wood girder w/embedded ice pick

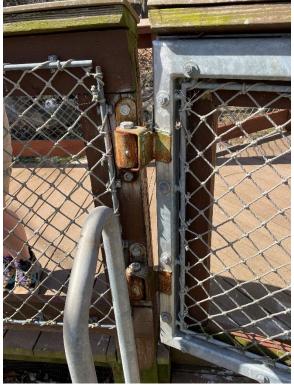
Photo 8 – Damaged jambs at gate connections

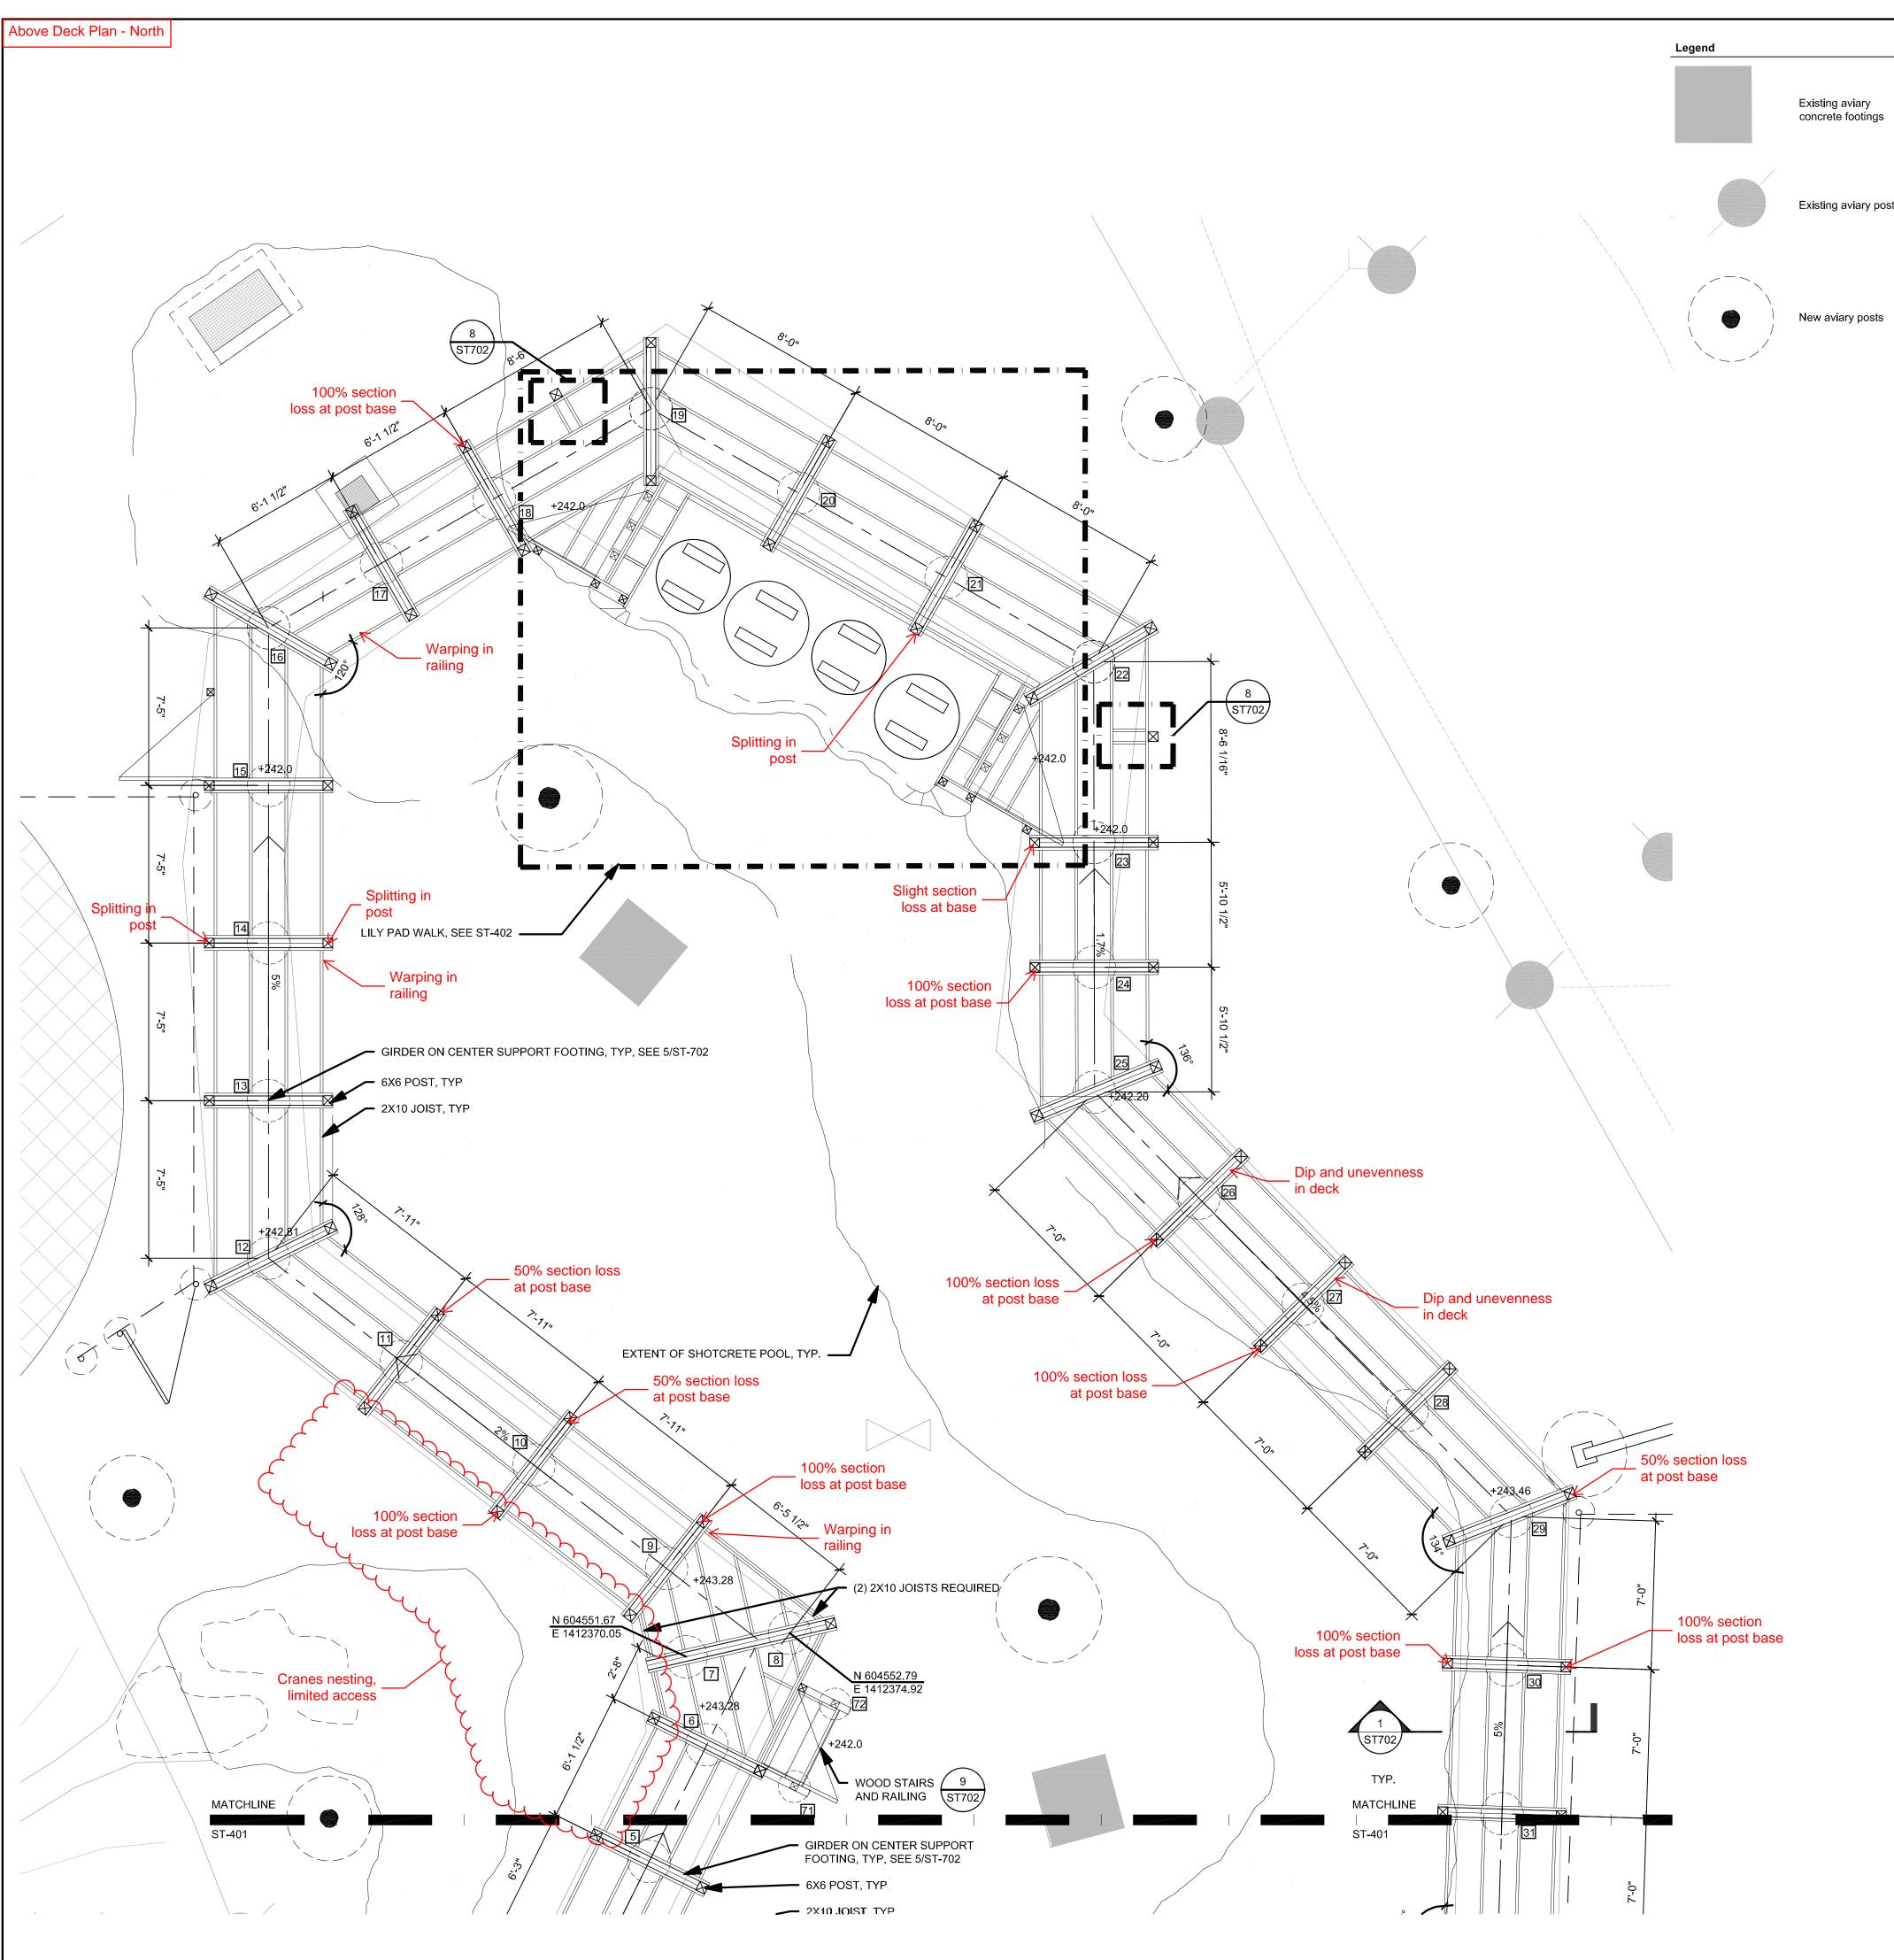
Boardwalk Layout Plan North

Construction drawings prepared by CLR Design were used for reference. See attached for marked-up plans indicating specific observations of handrail / framing deficiencies.
